Weapon and Sighting System Compatibility Assessment for Prototype Maxillofacial Protection Devices

ARL-TR-6367 March 2013

Frank Morelli and William H. Harper Human Research and Engineering Directorate, ARL

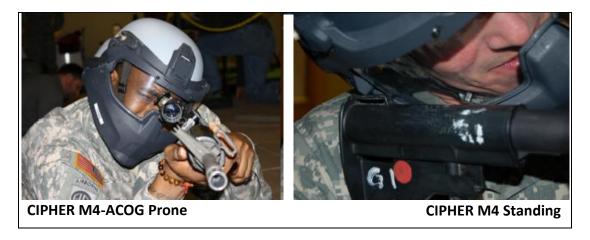
When in the standing posture, all three Soldiers were unable to obtain a proper sight picture for any of the weapon sights. As can be seen in figure 7 (right image), the CIPHER system visor and mandible guard displaces the shooter's face so far off the stock that using the M4 in a standing posture was not possible with any of the sighting systems. Generally, sighting offset causes optical distortions, with implications for performance and resultant eyestrain. Zeroing under conditions of misalignment has also proven detrimental to performance (Redden et al., 2006).

Figure 7. CIPHER, M4 carbine, prone/standing postures.

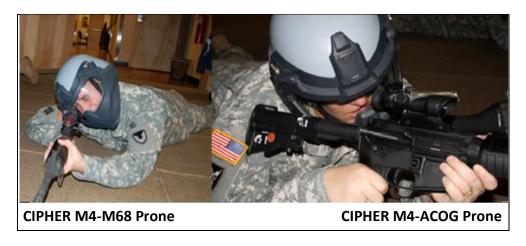
In the prone firing position, Soldiers also exhibited difficulty in obtaining a proper sight picture while wearing the CIPHER system (figure 8). Two of three Soldier participants were unable to obtain a proper sight picture across all sighting systems. As can be seen in the CIPHER prone images, the helmet system pushed the cheek and eye position so far off the stock of the weapon that it forced shooters into awkward head and neck positions in an attempt to obtain a sight picture, which ultimately remained a very difficult to impossible undertaking.

Figure 8. CIPHER, M4 carbine, prone posture.

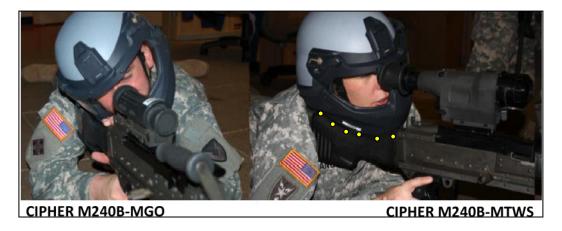
When using the MTWS, two Soldiers were able to acquire a full sight picture from a natural (i.e., comfortable) firing position. The remaining Soldier had difficulty obtaining a proper sight picture due to extreme head tilt and accompanying neck strain. The curved shape of the top portion of the M240B buttstock (highlighted in figure 9, right image) accommodates the side dimensions of the CIPHER system quite well, generally allowing Soldiers to achieve proper eye alignment behind the sights of the M240B.

Figure 9. CIPHER, M240B, prone posture.

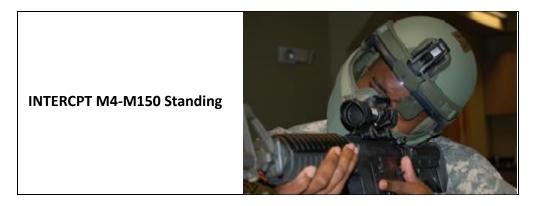
When in the standing posture, there was considerable difficulty in obtaining and maintaining a sight picture when using the M150 optic. Soldiers had to push the INTERCPT system into the buttstock with considerable force in an attempt to achieve a sight picture, resulting in severe head tilt and neck strain. This resulted in a partial sight picture at best for two Soldiers, with the remaining Soldier unable to achieve a sight picture at all (figure 10).

Figure 10. INTERCPT, M4 carbine, standing posture.

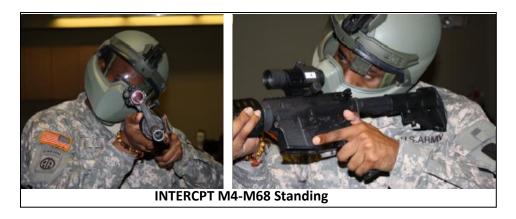
When using the M68 sight, obtaining a sight picture was more feasible relative to the M150 in a standing posture, but remained quite difficult to achieve and required severe head tilt, making the sight picture difficult to maintain (figure 11).

Figure 11. INTERCPT, M4 carbine, standing posture.

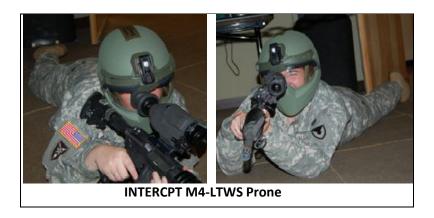
Using the M4 with LTWS made it very difficult to impossible to obtain a sight picture, in either the standing or prone firing positions. Achieving a sight picture required tilting the head to an angle approaching 45°. When Soldiers positioned their head naturally using the LTWS (as shown in figure 12), they generally could not achieve a full target sight picture.

Figure 12. INTERCPT, M4 carbine, prone posture.

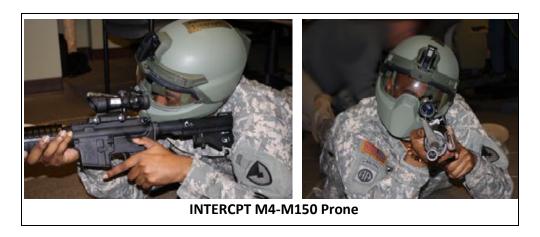
When in the prone firing position and using the M150 sight, there was some difficulty in acquiring the sight picture. However, once Soldiers were able to acquire a sight picture, they stated that maintaining it was feasible with some head tilt, which caused only mild accompanying neck strain (figure 13).

Figure 13. INTERCPT, M4 carbine, prone posture.

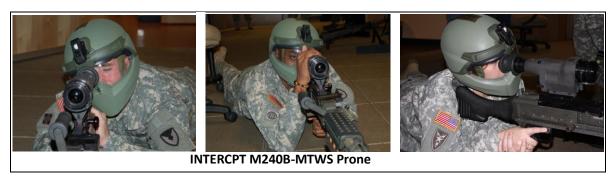
When using the MTWS, all Soldiers were able to acquire a full sight picture from a natural (i.e., comfortable) firing position without difficulty, though one Soldier noted that to maintain the sight picture would require pushing the front brim of the INTERCPT system rather than the eye and front cheek region against the MTWS's rubberized eyecup. Despite this, a steady firing posture that could reliably be maintained over time was achieved. As noted for the CIPHER system, the curved shape of the top portion of the M240B buttstock accommodates the side dimensions of the INTRCPT system well, allowing for proper eye alignment and relatively natural firing posture behind the sights of the M240B (figure 17).

Figure 17. INTERCPT, M240B, prone posture.

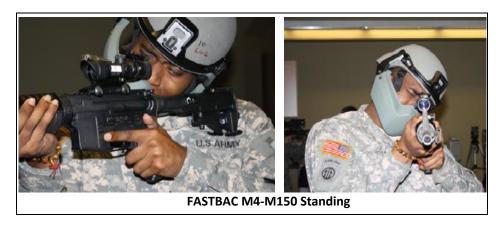
When in the standing posture, there was some difficulty in obtaining and maintaining a sight picture when using the M150 sight. This was due to eye-optic offset in excess of the allowable distance threshold, caused by interference from the sides of the maxillofacial protection system as the Soldier attempted to cheek the weapon (figure 18).

Figure 18. FASTBAC, M4 carbine, standing posture.

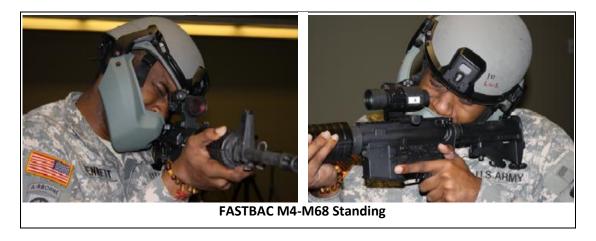
When using the M68 sight, obtaining a sight picture was easier relative to the M150. Less head and neck tilt was required, and there was less interference from the side of the maxillofacial protection system to achieve the required eye-optic alignment as Soldiers cheeked the weapon (figure 19).

Figure 19. FASTBAC, M4 carbine, standing posture.

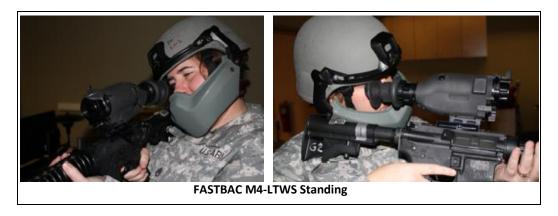
When using the LTWS, Soldiers found it very difficult to impossible to obtain a sight picture due to interference between the helmet brim, the sides of the maxillofacial protection system, and the weapon buttstock, all of which prevented the linear depression of the rubberized eyecup required to activate the sight (figure 20).

Figure 20. FASTBAC, M4 carbine, standing posture.

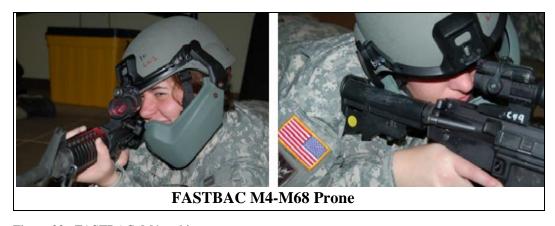
Relative to the M150, sighting the M68 optic was more straightforward, requiring less head tilt and a lesser degree of accompanying neck strain in order to achieve a sight picture (figure 22).

Figure 22. FASTBAC, M4 carbine, prone posture.

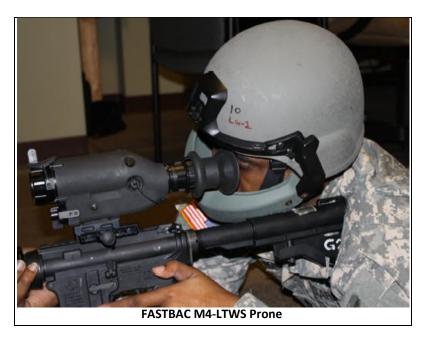
Soldiers were unable to acquire a sight picture when using the LTWS. They expressed considerable difficulty when attempting to depress the eyecup due to interference between the brim of the helmet and the front of the maxillofacial protection system (shown clearly in figure 23). Linear depression of the rubberized eyecup as it coupled flush with the eye socket and face was unachievable, thereby rendering the sight inactive.

Figure 23. FASTBAC, M4 carbine, prone posture.

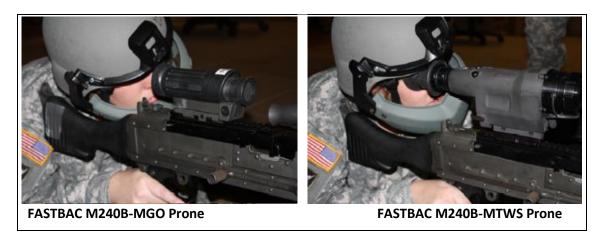
When in the prone firing position and using both the M145 MGO and the MTWS, Soldiers generally found it fairly easy to achieve a full sight picture. Sighting the weapon with both optics did not require much head tilt or accompanying neck strain, resulting in a high quality sight picture that was relatively easy to maintain (figure 24).

Figure 24. FASTBAC, M240B, prone posture.

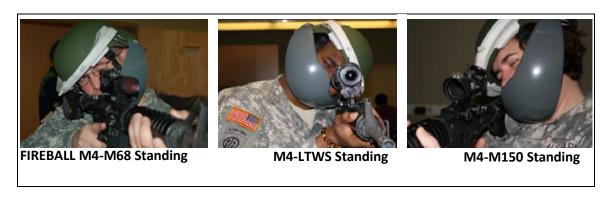
While wearing the FIREBALL system in the standing firing position and sighting the M68 and M150 optics, all Soldiers were able to attain a proper sight picture by firmly pressing the facial protection system against the side of the buttstock to shift the helmet (see figure 25). However, this posture caused considerable neck strain and head discomfort, and Soldiers felt that it would be very difficult to maintain the sight picture over time. When using the LTWS, two Soldiers were unable to achieve a sight picture. The remaining Soldier was able to achieve a sight picture by pressing the system against the stock of the weapon to shift the helmet on the head, but as with the M68 and M150 optics, felt that it would be difficult to maintain this sight picture over time due to the discomfort caused by this posture.

Figure 25. FIREBALL, M4 carbine, standing posture.

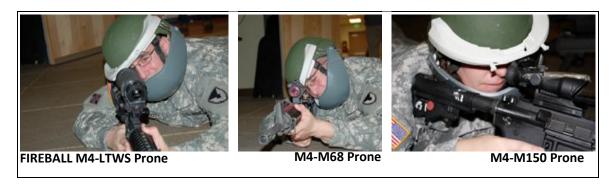
Wearing the FIREBALL system in the prone firing position and using the M150 sight, two of the Soldiers were unable to attain a proper sight picture. For these Soldiers, interference caused by the side of the FIREBALL system did not allow for the linear alignment required between eye and optic for proper sighting, even when attempting to press the system against the side of the buttstock as was described for the standing position under this configuration (figure 26, right image). The remaining Soldier was able to achieve a sight picture, but did not feel that maintaining it over time was a reasonable expectation given the extreme head tilt required, coupled with accompanying neck muscle strain. When using the M68 sight, all Soldiers were able to achieve at least a partial sight picture, but felt that it would be difficult to maintain it over time due to the neck tilt and strain required (figure 26, center). When using the LTWS, all three Soldiers had tremendous difficulty and were not able to achieve a sight picture due to interference between the rubberized eyecup, the helmet attachment mechanism (shown in white against the olive drab background of the helmet, figure 26, left image), and the front of the FIREBALL system.

Figure 26. FIREBALL, M4 carbine, prone posture.

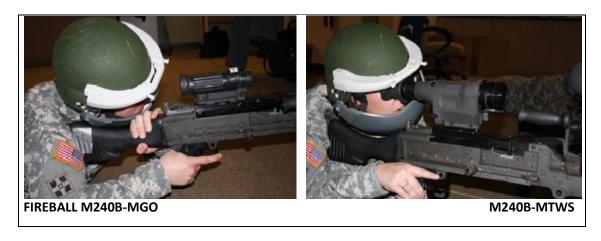
While wearing the FIREBALL system in the prone firing position, two Soldiers were able to achieve a full sight picture without difficulty using the M145 MGO. The remaining Soldier was also able to achieve a full sight picture, but reported difficulty acquiring and maintaining it due to the amount of head tilt and accompanying neck muscle strain associated with the sighting posture. When using the MTWS, two Soldiers were able to achieve a full sight picture without difficulty given the space between the FIREBALL system and the brim of the helmet, which easily accommodated the rubberized eyecup on the sight. The remaining Soldier was able to achieve a full sight picture, but found it difficult to maintain over time due to the degree of head tilt required (figure 27).

Figure 27. FIREBALL, M240B, prone posture.

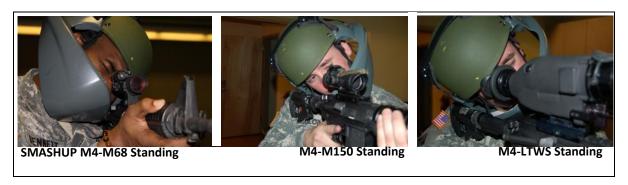
When wearing the SMASHUP system in the standing posture, there was some difficulty obtaining and maintaining a sight picture when using the M150 sight. All Soldiers found it difficult to shoulder and cheek the weapon naturally given the wide breadth of the SMASHUP system. Two were able to achieve a sight picture but reported severe head tilt and associated

neck strain, negatively influencing the ability to maintain the posture over time. A technique used by one Soldier to achieve target sight picture was to rest the side of the buttstock upon the upper "ledge" surface of the side of the SMASHUP system (images at center and right, figure 28). The remaining Soldier was unable to achieve a sight picture at all with the SMASHUP system, commenting that the form factor width was too extreme to allow for sighting with the M150. When using the M68 optic, all Soldiers were able to obtain a sight picture, but the severe degree of head tilt angle required caused them difficulty in maintaining the posture. When using the LTWS, all three Soldiers were able to achieve a full sight picture without difficulty given the accommodating space between helmet brim and SMASHUP system front, where the rubberized eyecup was easily inserted and depressed.

Figure 28. SMASHUP, M4 carbine, standing posture.

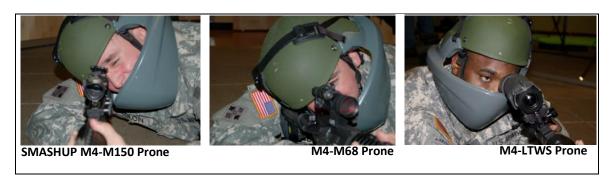
When in the prone firing position and using the M150 sight, there was some difficulty in acquiring and maintaining sight picture, with Soldiers commenting that the buttstock was forced from a natural, stable shoulder position toward an unstable position at the upper arm. When using the M68 sight, Soldiers had less trouble and reported less neck strain when attempting to maintain the sight picture relative to the M150 optic, but the posture nonetheless required significant head tilt and caused discomfort. When using the LTWS, one Soldier was unable to achieve a sight picture due to the severe head tilt and weapon cant required, with the two remaining Soldiers reporting difficulty in maintaining the sight picture they achieved due to the severe head tilt and weapon cant required (figure 29).

Figure 29. SMASHUP, M4 carbine, prone posture.

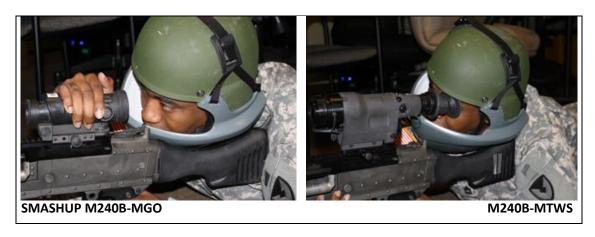
When in the prone firing position and using the M145 MGO, Soldiers generally found it difficult to achieve a full sight picture due to obstruction from the surface beneath the SMASHUP system's side "ledge," which prevented the buttstock from being adjusted easily along a vertical plane when attempting to sight the weapon (see image at left, figure 30). Nonetheless, two Soldiers were able to achieve a partial sight picture, with the third achieving a full sight picture albeit with considerable difficulty. When using the MTWS, Soldiers were able to achieve a full sight picture without difficulty due to the generous space between SMASHUP system front and helmet brim (right image, figure 30).

Figure 30. SMASHUP, M240B, prone posture.

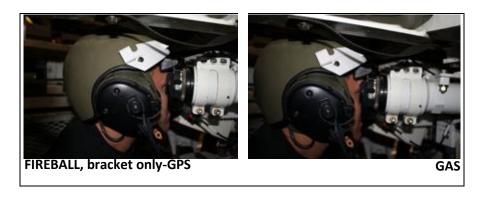
GTS - Sight picture was achieved without difficulty.

Figure 31. FIREBALL bracket only (STRYKER vehicle).

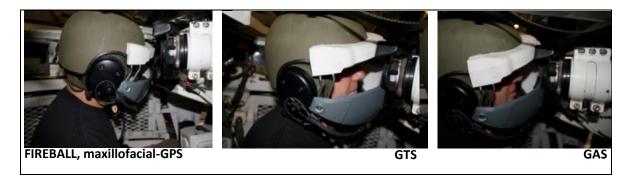
GPS and **GAS** - Sight picture was not achieved. FIREBALL system with maxillofacial protection caused the observer's head to be positioned beyond threshold standoff distance for both sighting systems.

GTS - Sight picture was achieved without difficulty.

Figure 32. FIREBALL bracket and maxillofacial protection (STRYKER vehicle).

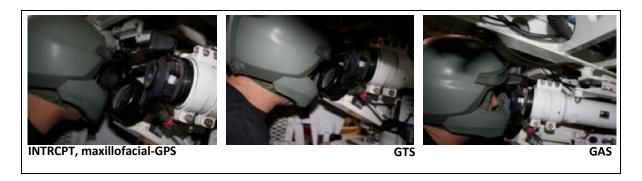
GAS - Sight picture was not achieved. INTERCPT system with maxillofacial protection caused the observer's head to be positioned beyond sighting threshold standoff distance.

Figure 36. INTERCPT bracket and maxillofacial protection (STRYKER vehicle).

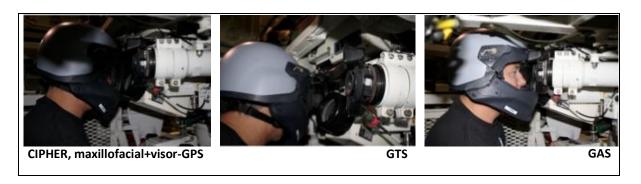
GAS - Sight picture not achieved. CIPHER system with maxillofacial protection and visor caused the observer's head to be positioned beyond sighting threshold standoff distance.

Figure 37. CIPHER with maxillofacial protection and visor (STRYKER vehicle).

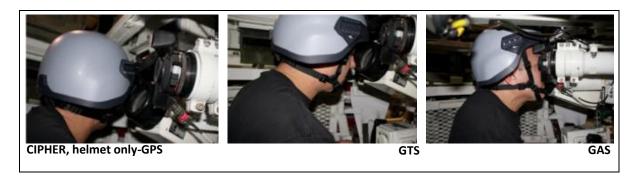
GAS - Partial sight picture achieved, with roughly 10% of the optimal FOV visible. Tilting the helmet backward improved sighting to full FOV.

Figure 38. CIPHER, helmet only (STRYKER vehicle).

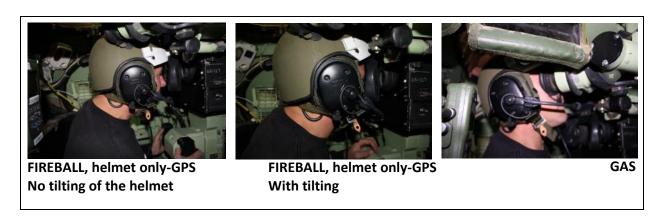
- **GPS** Partial sight picture achieved, with roughly 60% of the optimal FOV visible. Full FOV was visible when tilting the helmet.
- GTS Sight picture was achieved without difficulty.
- GAS Sight picture was achieved without difficulty.

Figure 41. FIREBALL bracket only (BFV).

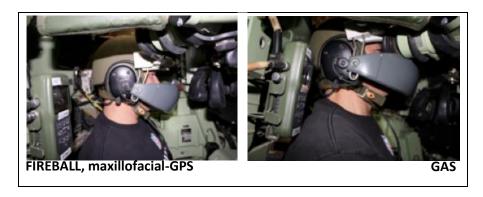
- **GPS** Partial sight picture achieved, with roughly 10% of the optimal FOV visible.
- **GTS** Sight picture was achieved without difficulty.
- **GAS** Sight picture was unattainable. For both the GPS and the GAS, maxillofacial protection system components interfered with the brow pad on the sights, causing the observer's head to be positioned beyond sighting threshold standoff distance.

Figure 42. FIREBALL bracket and maxillofacial protection (BFV).

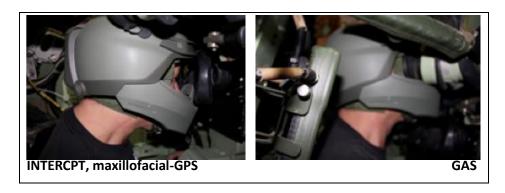
- **GPS** Partial sight picture achieved, with roughly 50% of the optimal FOV visible.
- **GTS** Sight picture was achieved without difficulty.
- **GAS** Sight picture was achieved without difficulty.

Figure 43. INTERCPT with maxillofacial protection (BFV).

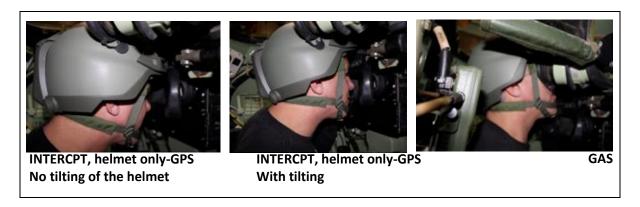
- **GPS** Partial sight picture achieved, with roughly 50% of the optimal FOV visible. The prototype HUD device hanging from the helmet interfered with the brow pad on the GPS, increasing standoff from the sighting system. However, tilting the helmet backward improved sighting to roughly 90% FOV and largely cleared the HUD obstruction.
- GTS Sight picture was achieved without difficulty.
- **GAS** Full FOV was achieved straightaway without tilting the helmet backward.

Figure 44. INTERCPT, helmet only (BFV).

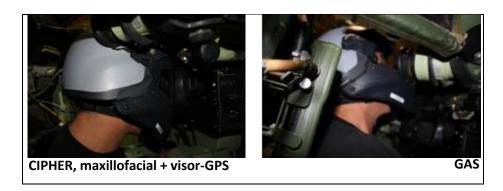
- GPS Partial sight picture achieved, with roughly 40% of the optimal FOV visible.
- **GTS** Sight picture was achieved without difficulty.
- **GAS** Sight picture not achieved. CIPHER system with maxillofacial protection and visor caused the observer's head to be positioned beyond sighting threshold standoff distance.

Figure 45. CIPHER with maxillofacial protection and visor (BFV).

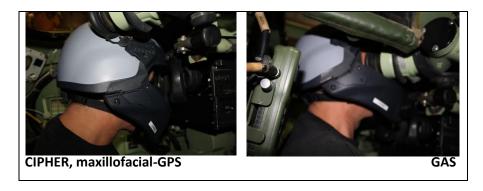
- **GPS** Partial sight picture achieved, with roughly 40% of the optimal FOV visible.
- GTS Sight picture was achieved without difficulty.
- GAS Sight picture was achieved without difficulty.

Figure 46. CIPHER with maxillofacial protection, no visor (BFV).

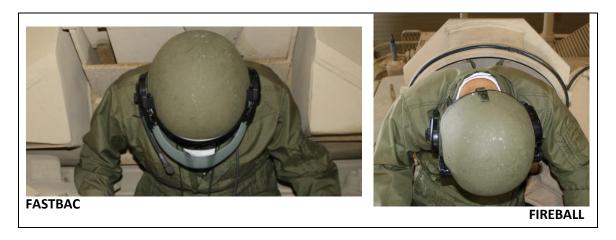
Wearing the CVCH with the FASTBAC maxillofacial protection system forced the user to tilt the head lower than when no maxillofacial system was employed during ingress and egress maneuvers. This was necessary for visibility of hand and foot positioning during ingress, egress, and for navigation across the top surface of the vehicle during mounting/dismounting. Given the FIREBALL system's more restricted vertical field of view (essentially a more narrow available viewing space between the front edge of the CVCH and the top front edge of the FIREBALL maxillofacial system), using the CVCH with the FIREBALL maxillofacial protection device exacerbated this effect, requiring the operator to tilt the head down at more oblique angles relative to wearing the FASTBAC (an example of this effect is shown in figure 48).

Figure 48. Operator ingress/egress visibility head position adaptations.
